AS-BUILT

PLAN & DETAILS

**BARKLEY ROAD PASSIVE TREATMENT SYSTEM**

**STREAM RESTORATION INCORPORATED**

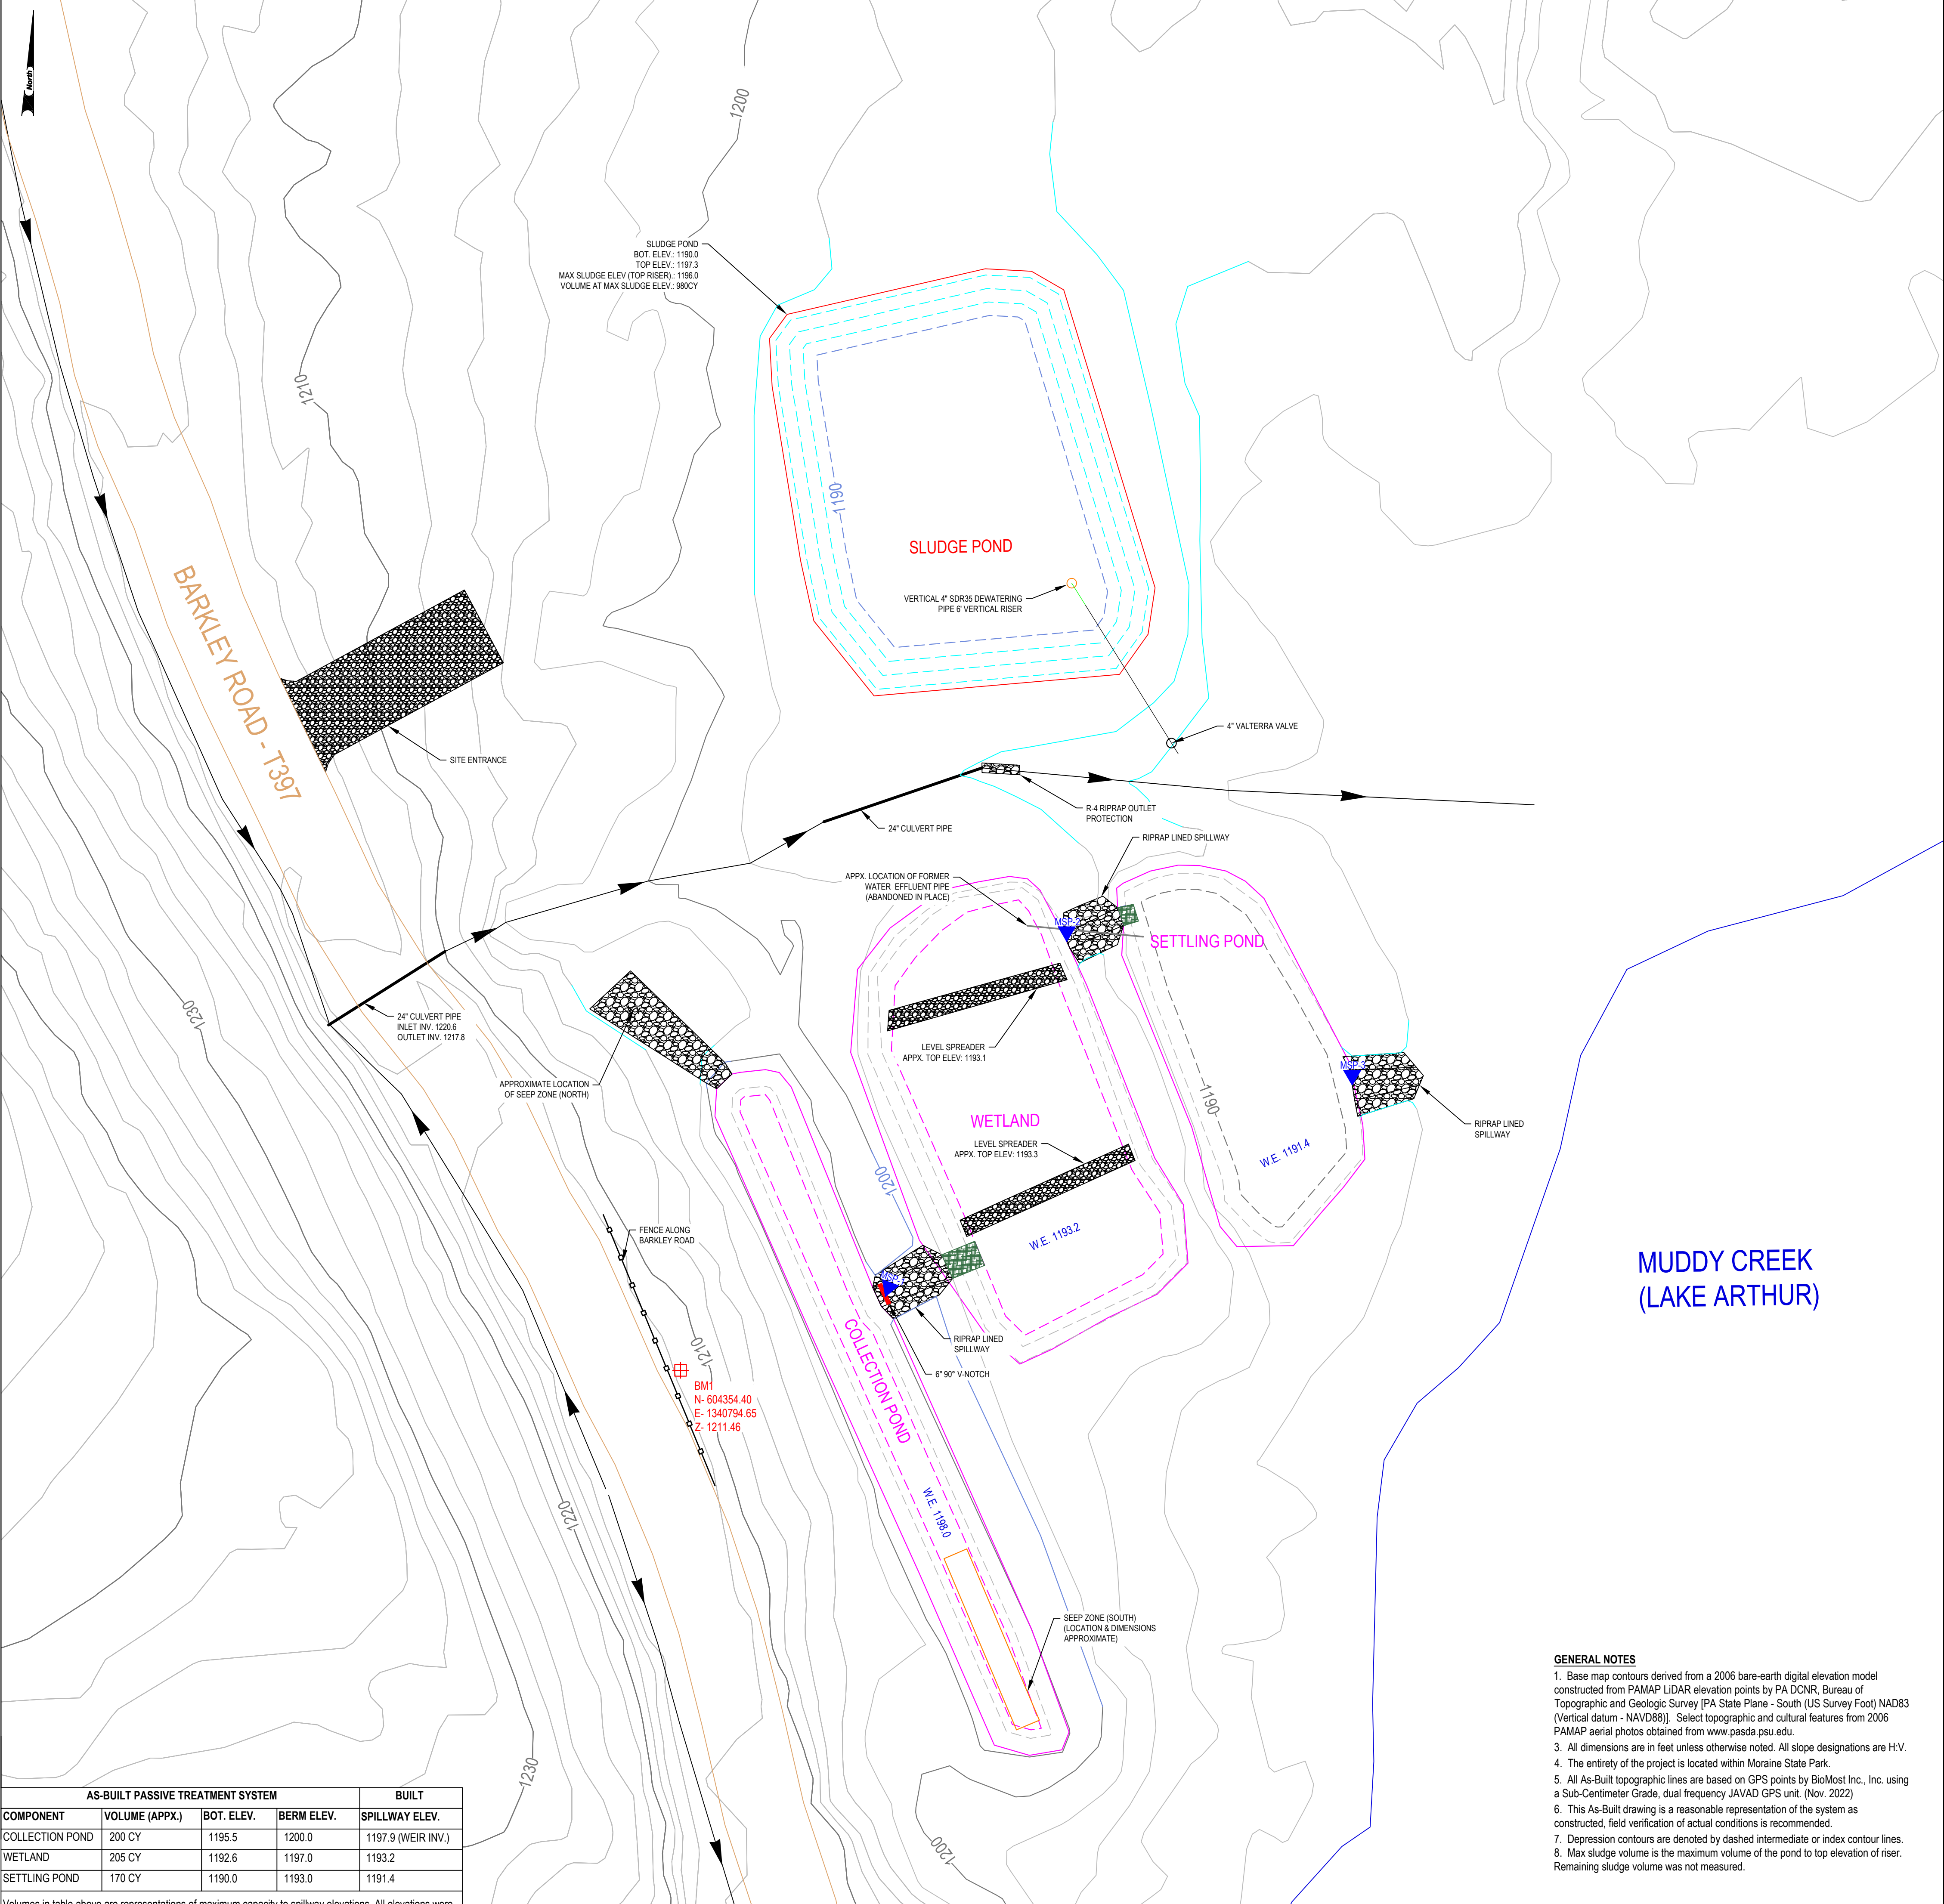
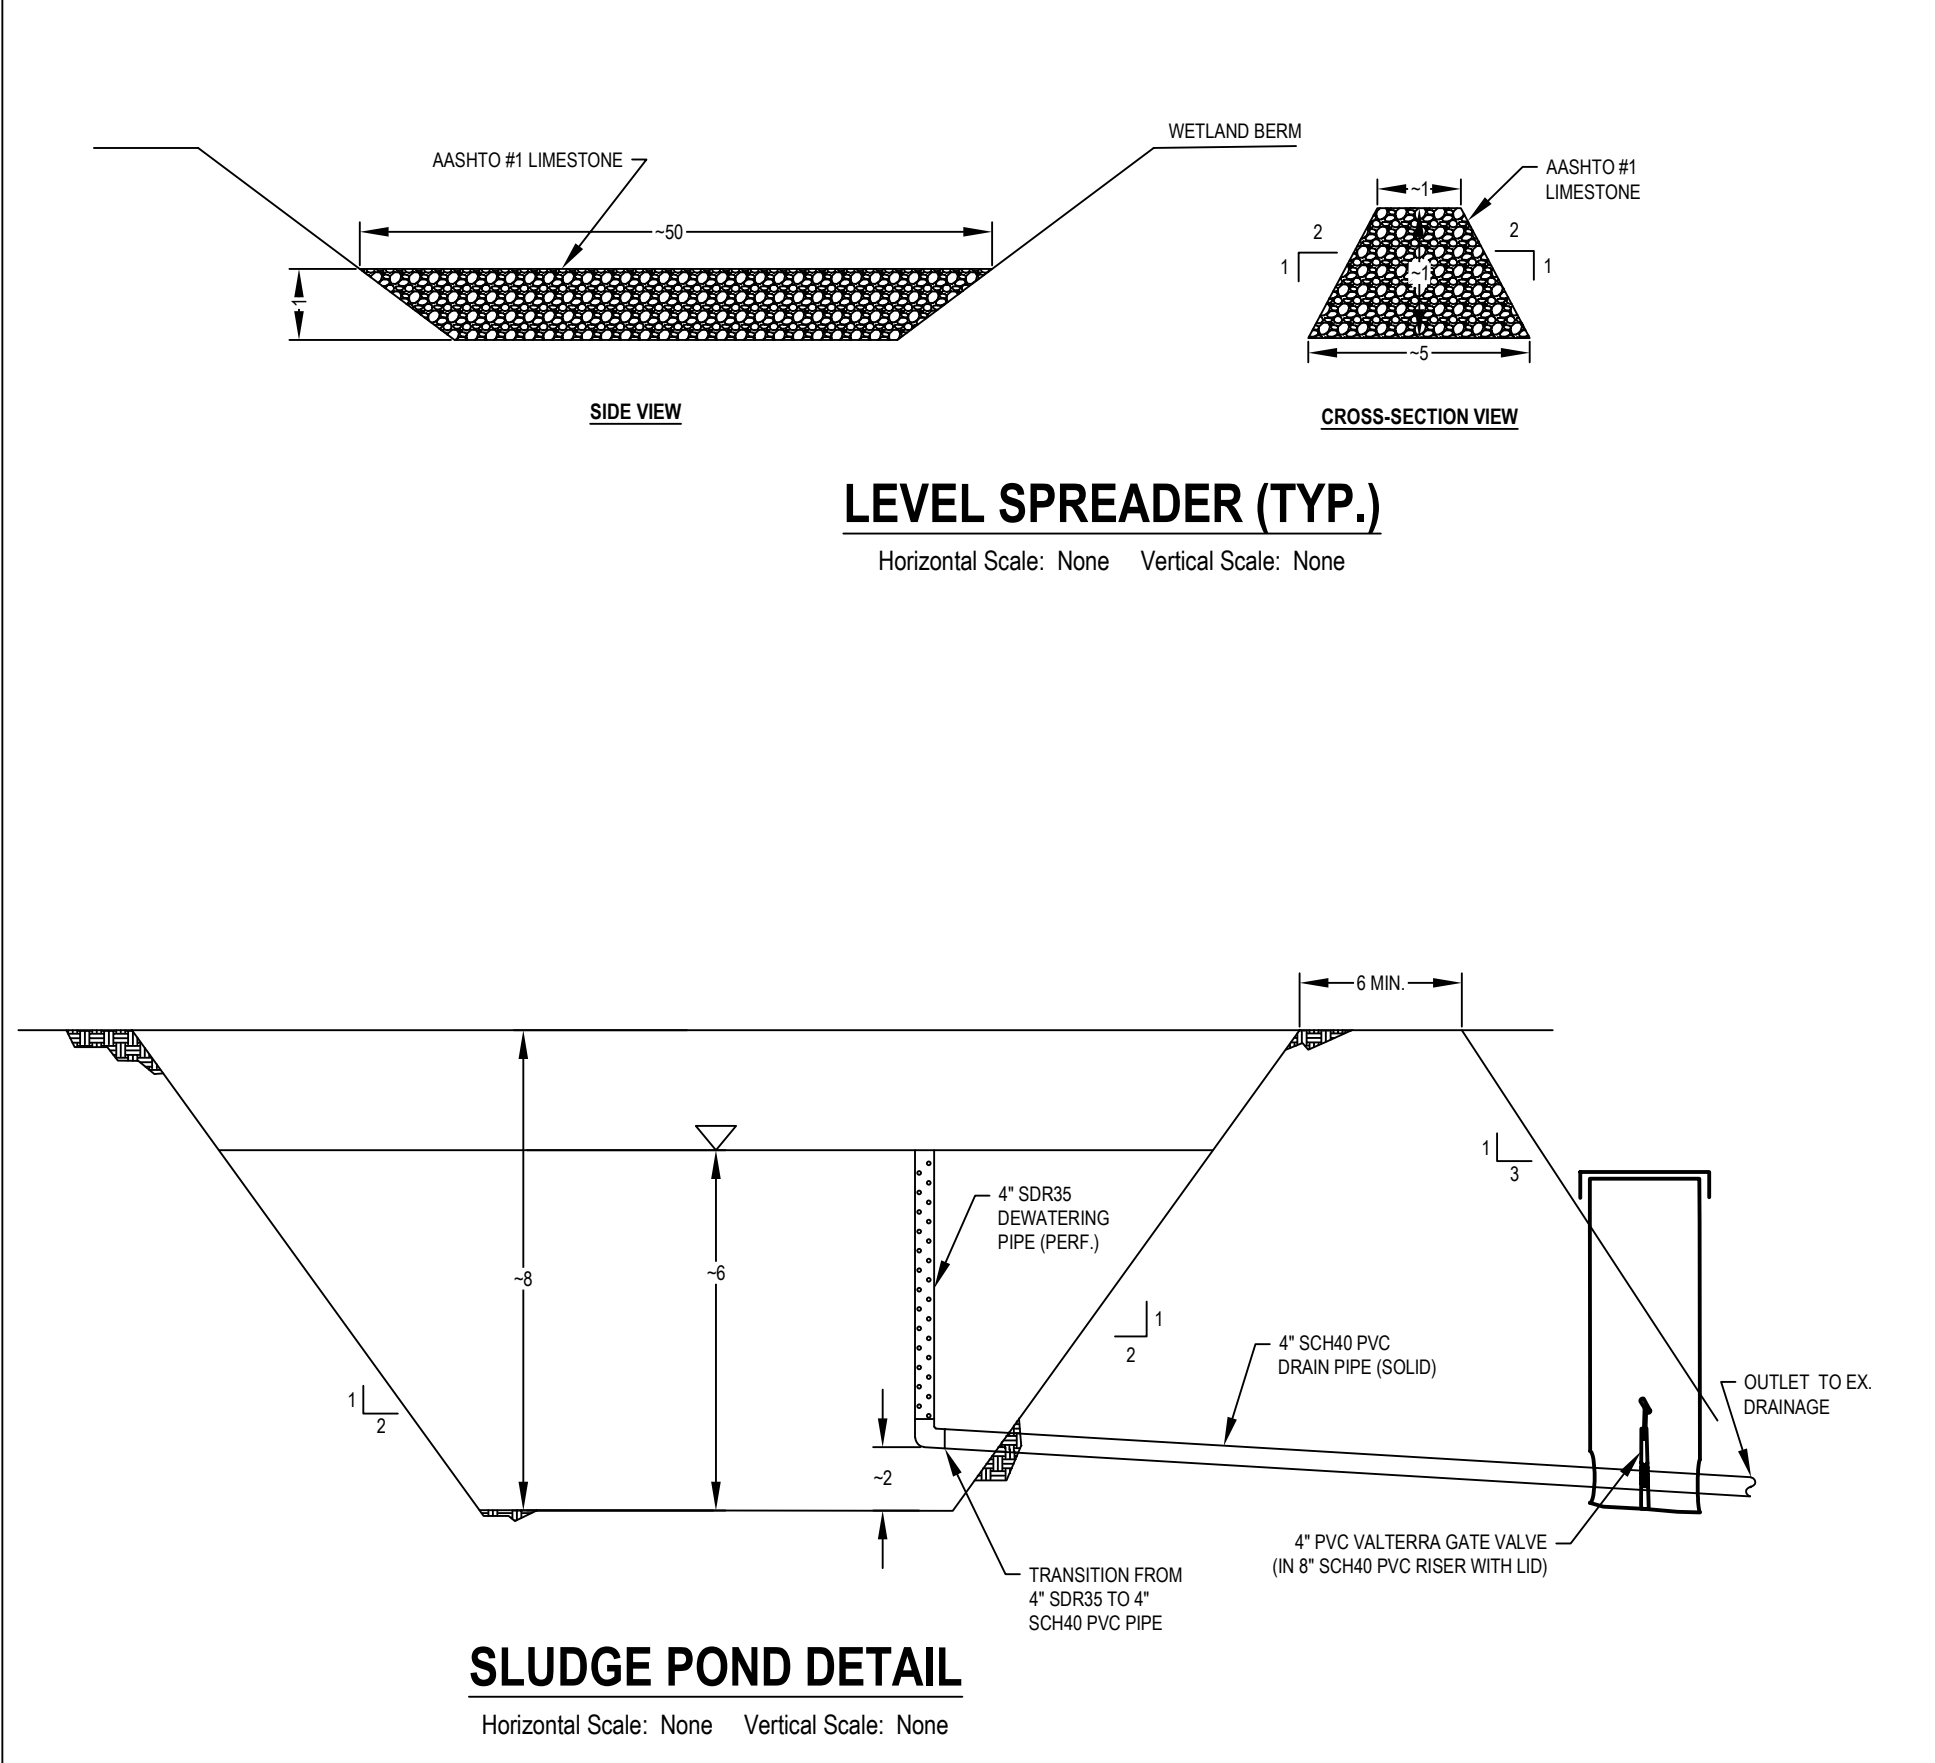
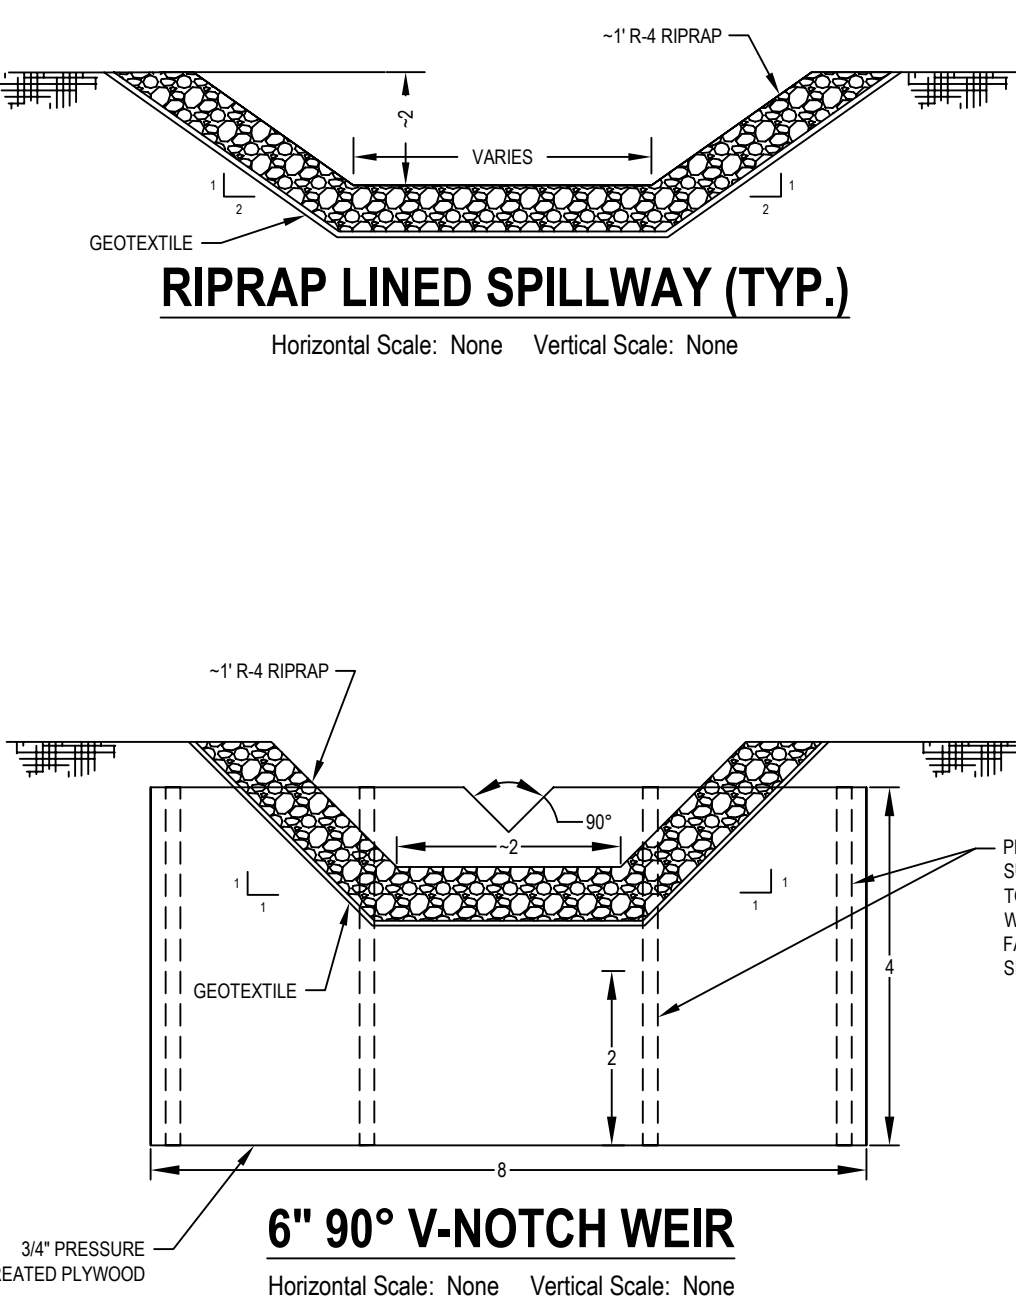
| AS-BUILT PASSIVE TREATMENT SYSTEM | | | | BUILT |
| COMPONENT | VOLUME (APPX.) | BOT. ELEV. | BERM ELEV. | SPILLWAY ELEV. |
| COLLECTION POND | 200 CY | 1195.5 | 1200.0 | 1197.9 (WEIR INV.) |
| WETLAND | 205 CY | 1192.6 | 1197.0 | 1193.2 |
| SETTLING POND | 170 CY | 1190.0 | 1193.0 | 1191.4 |

Volumes in table above are representations of maximum capacity to spillway elevations. All elevations were used from GPS survey of 11/14/2022.
