OPERATION, MAINTENANCE, and REPLACEMENT PLAN

Richards Passive System Rehabilitation

| System Components: | Mine Drain; Raw Water Pipeline; Flow Splitter Box; Jennings-type Vertical Flow Ponds 1, 2, & 3; Settling Pond; Wetland |

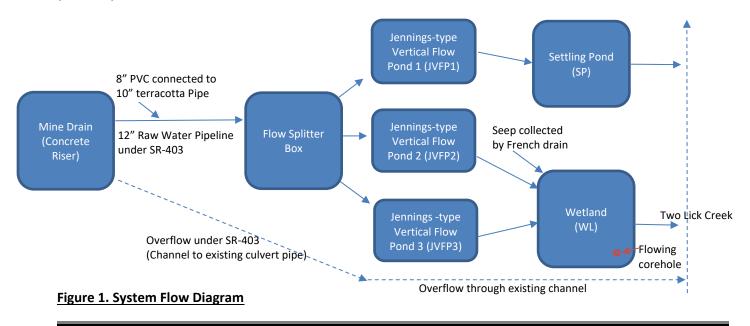
The Richards Passive System is located in Cherryhill Township near Clymer, PA adjacent to Iron Horse Salvage along State Route 403 (SR-403). The rehabilitated Richards Passive System was put online in June 2021. Flow from an abandoned underground coal mine drain (concrete riser) is piped to a three-way flow splitter box and proportionally distributed among three Jennings-type vertical flow ponds (JVFPs) that flow to either a settling pond or wetland as shown in Figure 1. A seep located between JVFP2 and JVFP3 is captured in a French drain and piped to the wetland. A flowing artesian corehole discovered during previous construction efforts contributes degraded water to the final 1/3 of the wetland. This OM&R Plan has been prepared as part of the final report documents prepared December 2021 and uploaded to <u>www.datashed.org.</u> Other final report documents include: One-page summary, Narrative, Photographs, Water Monitoring Data, and As-Built Drawings (2 sheets).
