Fox Run Restoration Project- Phase II Passive Treatment System SRI O&M TAG Project # 27 Request #1 OSM PTS ID: PA-297

Passive Treatment Operation & Maintenance Technical Assistance Program Funded by PA DEP Growing Greener & Foundation for PA Watersheds Stream Restoration Incorporated & BioMost, Inc.

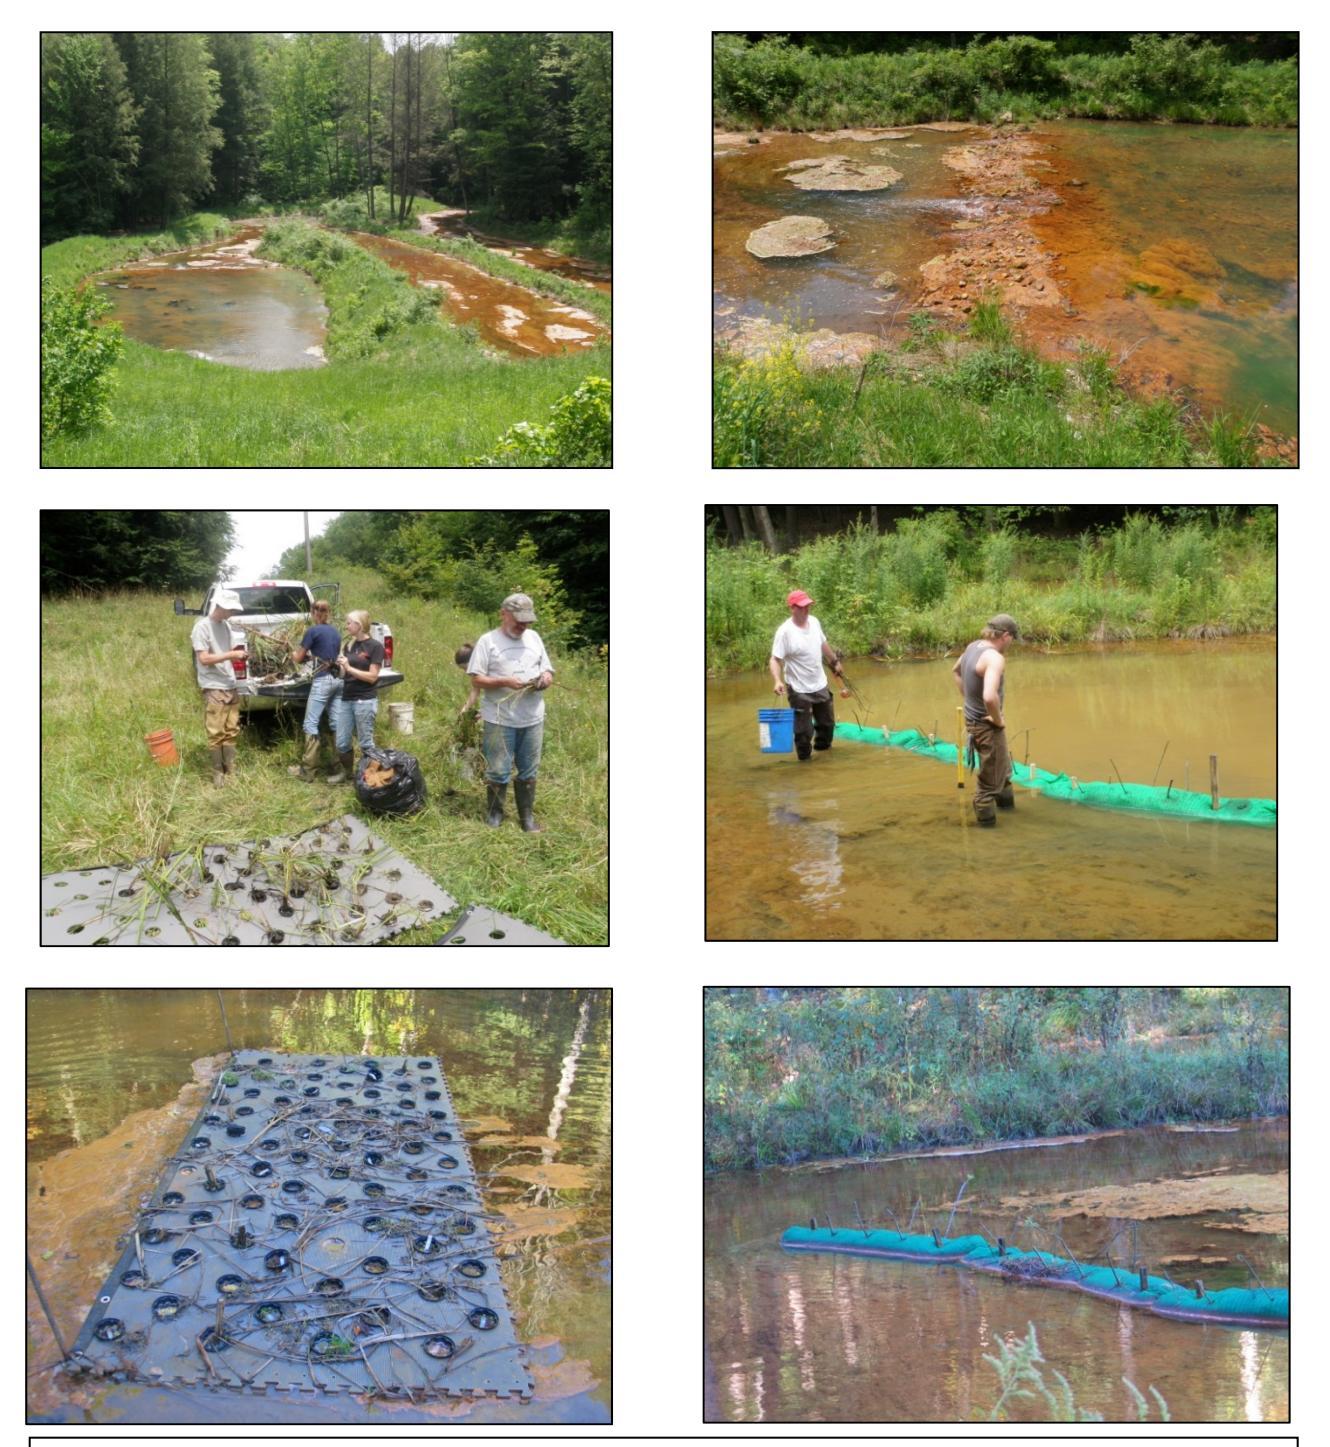
The Fox Run Phase 2 passive system consists of a discharge collection system with piping beneath Fox Run, a settling pond with aeration platform, and an aerobic wetland *(top left and right)*. Establishing vegetation in the wetland has been problematic, which appears to be responsible for the limited iron removal. To encourage successful vegetation, floating wetland islands with wetland plants *(middle left)* and compost filter socks with live stakes *(middle right)* were installed. Continued significant animal browsing activity post-installation, however, has reduced the growth of plants in both the wetland islands and compost filter socks *(bottom left and right)*.

On 5/23/13 Shaun Busler met with Shawn Hedglin of the Mercer County Conservation District (MCCD) to visit the site and discuss options to address both the lack of vegetation within the wetland and low iron removal rates. In September 2013, partnering with the MCCD and volunteers, Stream Restoration Incorporated (SRI) and BioMost, Inc., (BMI) worked to establish vegetation along and within the treatment system. New methods employed included the use of compost filter socks and floating wetland islands to provide growth media.

Compost filter socks were secured within the system and planted with live stakes. Floating ecoislands were installed to encourage growth and create a healthier ecosystem within the settling pond. Unfortunately, site visits in months after installation again revealed significant animal browsing activity, reducing growth of plants in the eco-islands and compost filter socks. Subsequent site visits are planned for 2015 to reassess plant growth and make further recommendations, as needed.
