Bear Run Phase 1 Passive Treatment System
SRI O&M TAG Project # 10 Request #1
OSM PTS ID: PA-306

Requesting Organization: Indiana County Conservation District (in-kind partner)
Receiving Stream: Bear Run (Bear Run Watershed)
Hydrologic Order: Bear Run→West Branch Susquehanna River→Susquehanna River
Municipality/County: Banks Township, Indiana County.
Latitude/ Longitude: 40°51'46.0008"N / 78°50'53.0016"W
Construction Year: 2008

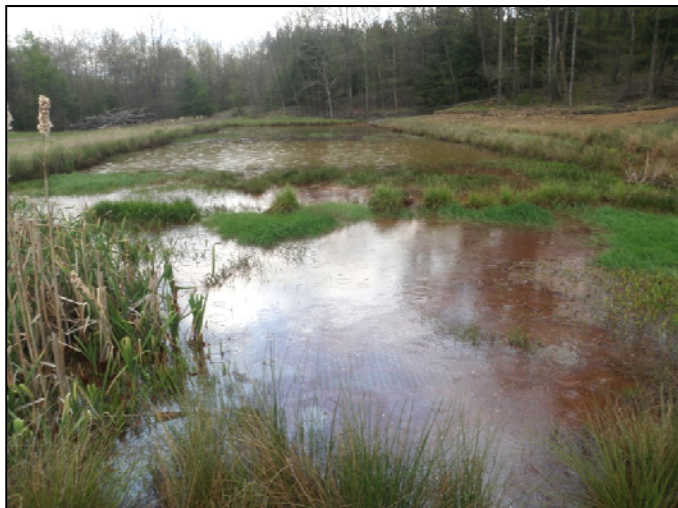
An inlet box and pipe had become plugged at the Bear Run Phase 1 Passive Treatment System causing the water level to rise in the Pre-treatment Wetlands (*top left*). BioMost, Inc., worked with volunteers from the Indiana Conservation District, Evergreen Conservancy, and the Susquehanna River Basin Commission to unplug the pipe (*top right*). Once the clog was eliminated, the water level quickly returned to normal (*bottom*).

On 4/11/12, SRI was contacted by Adam as the same pipe had become plugged again. On 5/4/12, Cliff Denholm met Adam Cotchen and Megan from the ICCD, John Dudash from Evergreen Conservancy, and Tom Clark from the Susquehanna River Basin Commission to investigate the site. Using a clean-out tool provided by BMI, the pipe was unplugged. The group assisted in the process and determined that they could build a similar clean-out tool themselves for future issues.
