Oven Run A Passive Treatment System
SRI O&M TAG Project # 11 Request #1
OSM PTS ID: PA-77

Requesting Organization: Somerset County Conservation District (in-kind partner)
Receiving Stream: Oven Run (Oven Run Watershed)
Hydrologic Order: Oven Run→Stonycreek River→Conemaugh River→
Kiskiminetas River→Allegheny River→Ohio River
Municipality/County: Shade Township, Somerset County
Latitude/Longitude: 40°06'06.0012"N / 78°54'47.0016"W
Construction Year: 2003

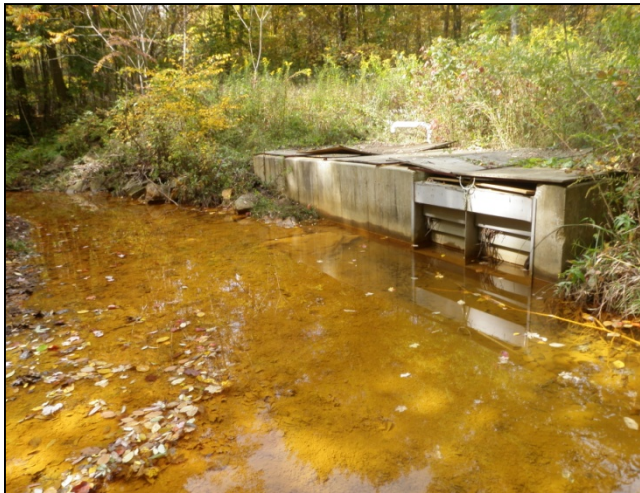
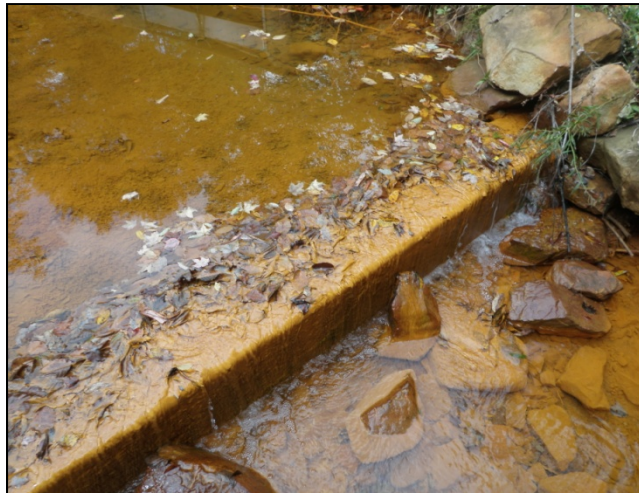
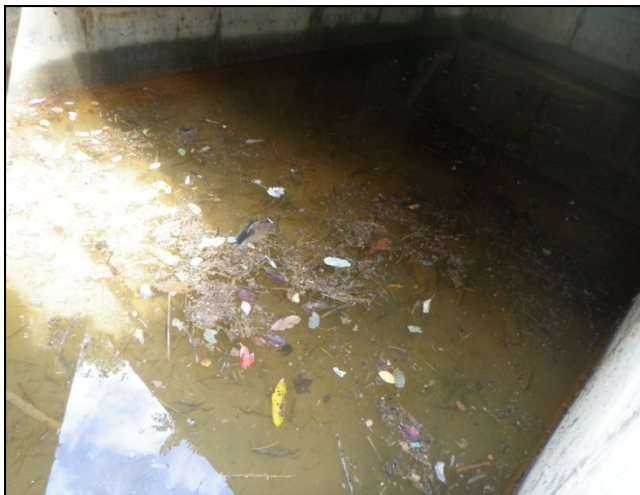
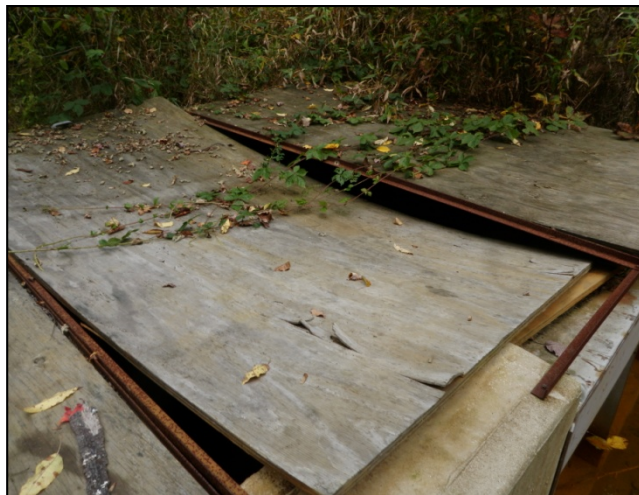
At the Oven Run A Passive Treatment System, a stream in-take structure (*top left*) was built to divert up to 200 to 300 gpm of the stream to the passive system, but the flow rate entering the treatment system was significantly less, which may be in response to several issues. It is possible, that the conveyance pipe from the intake to the system is plugged and needs to be cleaned by a power-snake, water-jetter, etc. Several cleanout manholes can be utilized to provide access to the conveyance pipe. A build-up of sediment and debris in front of the dam (*top right*) may be limiting the flow entering the in-take. In addition, the sediment and debris inside the in-take structure (*bottom left*) may also be limiting the flow into the system. Also consider replacing the compromised wooden covers on the in-take structure (*bottom right*) as part of general site maintenance and safety.

- Clean sediment and debris from in-take structure.
- Replace the cover on the in-take structure for safety considerations.
- Clean conveyance pipe with a power snake, water-jetter, or similar equipment.
- Consider removing sediment and deepening the area in front of the dam.
- In the future, evaluate and consider moving the in-take closer to the system if possible. (Landowners, elevation change, construction conditions, etc. may be potential issues preventing relocation.)
- Potentially increase the height of the dam.
- Re-evaluate the system after water is returned to the system.

In 2014, the SCCD received \$704,000 grant to address O&M issues within the Oven Run Watershed. At this site, the SCCD has cleaned debris from the in-take box and installed a grate to reduce debris entering the box. Flow rates have since increased to over 100 gpm. Additional work may be completed in the future. The project team thanks the Somerset County Conservation District for all of their efforts including support and assistance.
