Big Run #2 Passive Treatment System
SRI O&M TAG Project # 18 Request #1
OSM PTS ID: PA-17

Requesting Organization: Blackleggs Creek Watershed Association (in-kind partner)
Receiving Stream: Big Run (Blackleggs Creek Watershed)
Hydrologic Order: Big Run→Blackleggs Creek→Kiskiminetas River→
Allegheny River→Ohio River
Municipality/County: Conemaugh Township, Indiana County
Latitude/Longitude: 40°32'53.9988"N / 79°24'56.9988"W
Construction Year: 2004

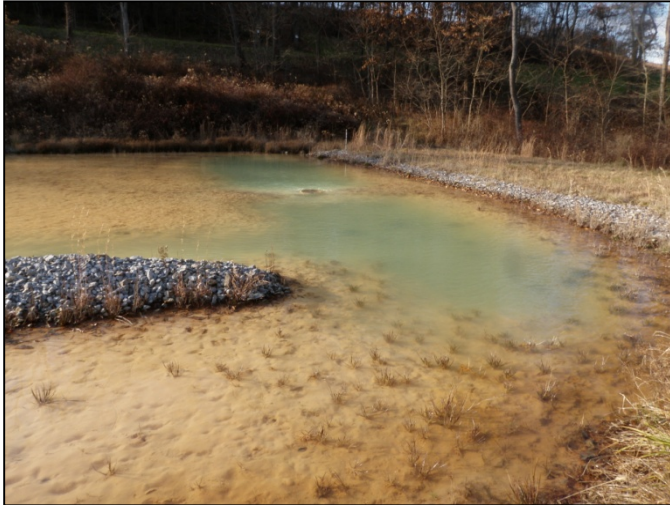
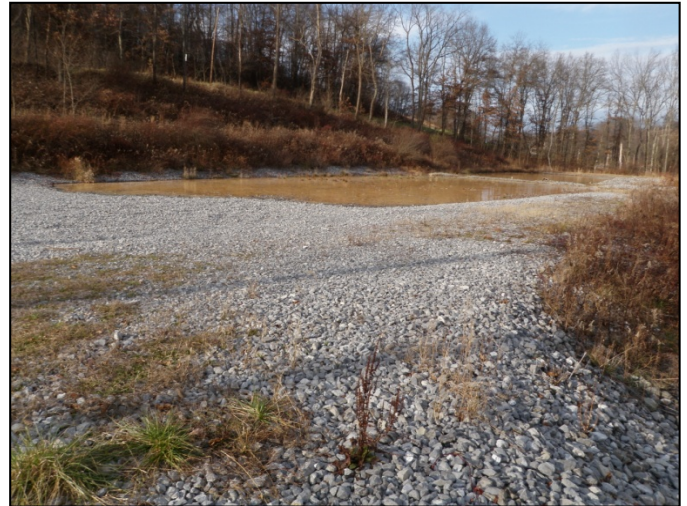
The Big Run #2 Passive Treatment System limestone bed had become clogged with iron and aluminum solids (*top left & right*). Art Grguric of Blackleggs Creek Watershed Association cleaned the limestone aggregate (*middle left*) and installed a flow distribution pipe (*middle right*). Art regularly flushes the bed by removing stop-logs from the Agridrain flow control box (*left*). To reduce maintenance, retrofitting the outlet with a valve, siphon or Agridrain SmartDrain, etc. may be a consideration.
