Slippery Rock Passive Treatment Rehab & Maintenance

Washington & Venango Townships, Butler County, Pennsylvania
Grant Document Number: C990000637

A Slippery Rock Watershed Coalition Project

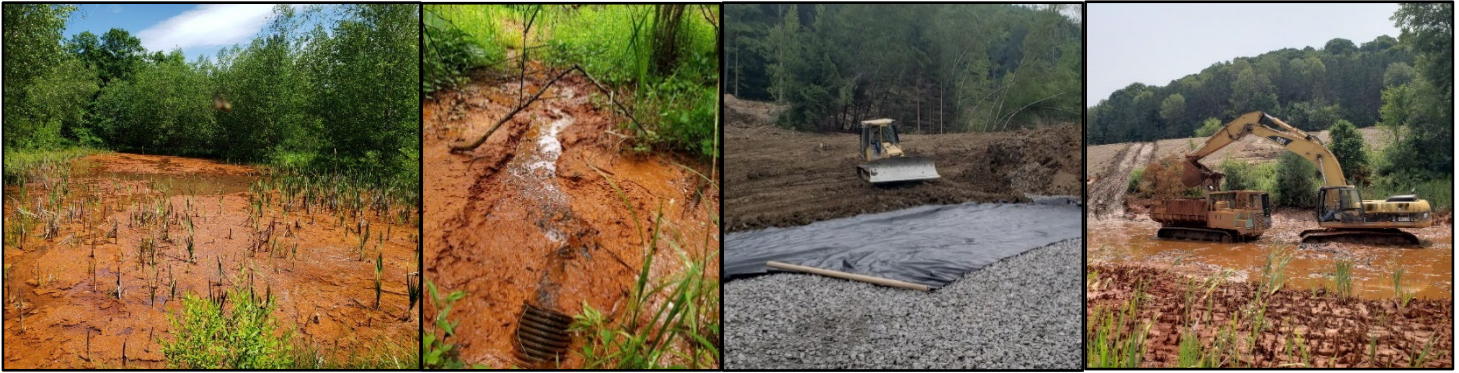
Before/During Rehabilitation: (From Left to Right) Pond D2 at SR1114D full of iron sludge and debris (2020); Iron sludge build up around SR114B ALD outlet pipe prior to rehabilitation (2020); Spurr Excavation, LLC finishing reconstruction of SR114 ALD D; Spurr removing sludge and debris from settling pond at SR81.

Project Description: Five passive systems constructed between 1995 and 2002 to treat AMD in the headwaters of Slippery Rock Creek had performed well for >20 years and exceeded their design life but needed rehabilitated as limestone was consumed, treatment media degraded, metal sludge accumulated, pipes compromised and other issues. The Ferris Complex consists of two passive systems constructed in 1997 to treat four AMD discharges. The **Ferris SR85/SR86 (VK)** system was improved by redesigning and reconstructing existing VFPs into Jennings's-style mixed media (limestone, compost, and wood chips) vertical flow ponds (JVFPs) and reconfigured to operate in parallel. Further changes involved installing a terraced iron formation (TIF) and a flow splitter box. While not part of the original grant, major maintenance was performed at the **Ferris SR87/SR88 (JP)** system including replacing a plugged culvert that conveyed AMD, installing pipes for flow measurements, and washing the limestone only VFP. In addition, large dual culvert pipes under the access road between Wetland 1 and 2 had failed and were replaced with a drivable spillway. The **SR81** system was originally designed to treat 60 gpm; however, during construction in 2002, the mine pool was accidentally hit increasing flow to about 200 gpm increasing the pollutant load. SR81 was redesigned with increased treatment capacity. Rehabilitation included enlarging the anoxic limestone drain (ALD), reconfiguring the settling pond and wetland, and constructing a unique z-pile moat and rock berm flow distribution features to utilize an existing AMD impacted natural wetland for additional treatment. Accumulated treatment sludge was removed from the system and placed in a newly constructed dewatering basin. The **SR101A** system was constructed in 1998 consisting of an ALD, settling pond and wetlands. Accumulation of sludge had reduced treatment capacity. Maintenance was conducted including removing sludge/organic debris from the system and placing into a newly constructed pond. **SR114B** and **SR114D** were constructed in 1995. After 28 years of successful operation with little maintenance, they needed to be rebuilt. The ALDs were expanded, and new limestone added, settling ponds and wetlands full of sludge were cleaned and placed in a dewatering basin, Pond B was expanded, and baffle curtains were installed.

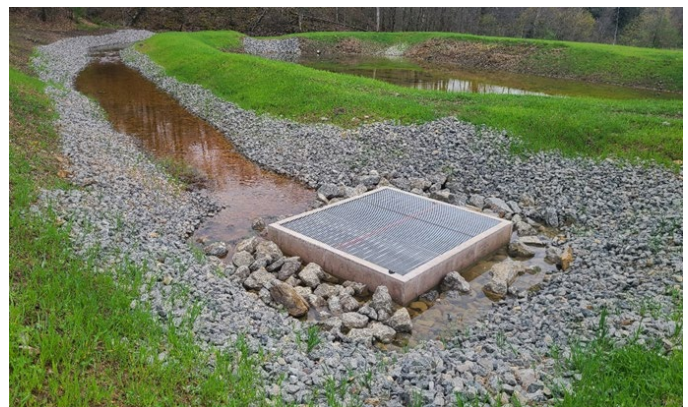
After Rehabilitation: Terraced iron formation (TIF) and flow splitter box at the Ferris SR85/86 passive system with the JVFP East (VK1) in background.
