**Weaver Run Restoration
Growing Greener Grant 2009
Awarded to Paint Creek Regional Watershed Association**

Final Report

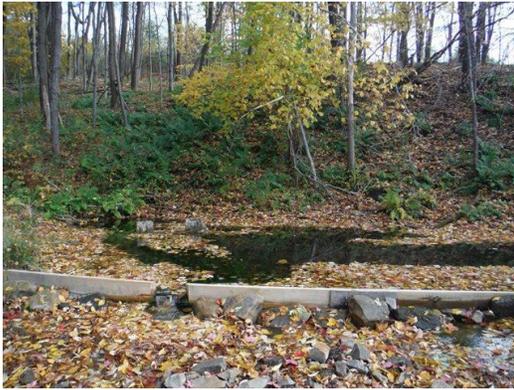
Left, Weaver Run Discharge D10. Right, D10 Treatment System.

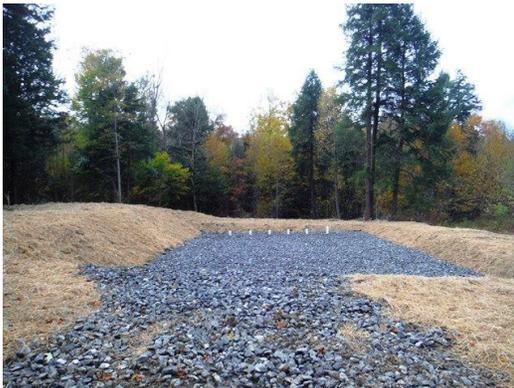
Left, D8B (Lower) Treatment System. Right, D8A (Upper) Treatment System.
